Manhole Inspection Summary

Manhole # S21K__004MH

Insp Date: **9/26/07 11:23 AM**

Location Address: **1812 PRATT ST**

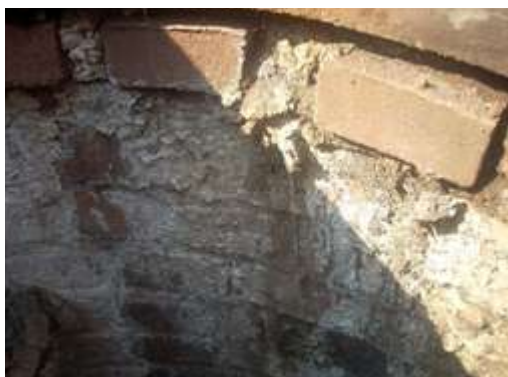
Defect 5

Infiltration: ☐ None ☒ **Joint** ☐ Cracks ☐ Mortar ☐ Roots ☐ Wall

INFILTRATION OF THE CHIMNEY JOINT

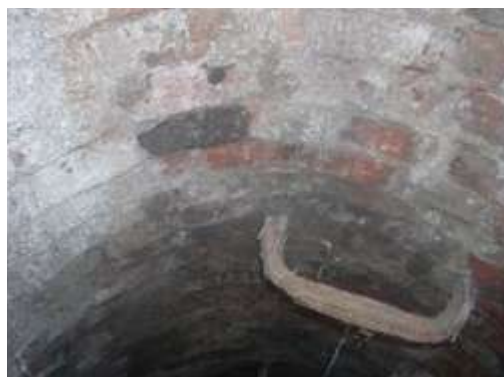
Defect 4

Infiltration: ☐ None ☐ Joint ☐ Cracks ☐ Mortar ☐ Roots ☒ **Wall**

INFILTRATION OF CORBEL WALL

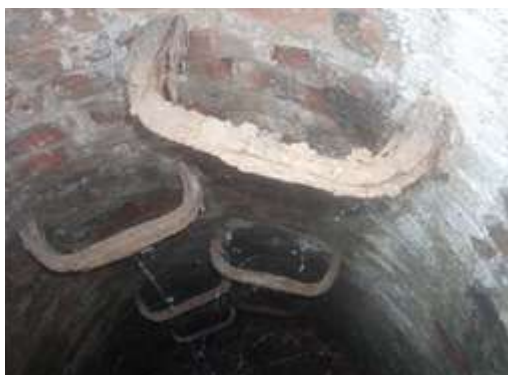
Defect 3

Count: **6** Missing: **0** ☒ **Corroded**

CORRODED STEPS

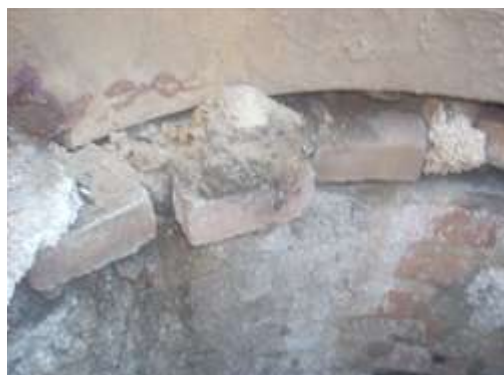
Defect 2

Condition: ☐ Sound ☐ Cracked ☐ Root Intrusion ☒ **Loose Brick** ☒ **Deteriorated**

DETERIORATED CHIMNEY WITH LOOSE BRICKS

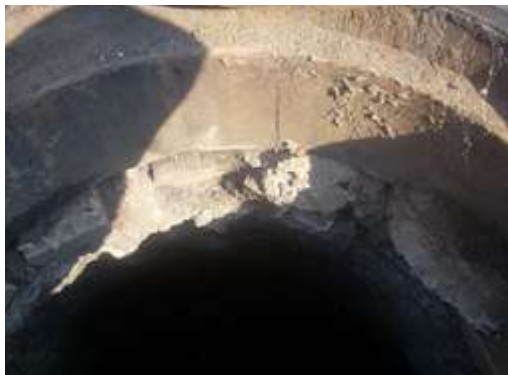
Defect 1

Offset: **3** (in.)

FRME OFFSET

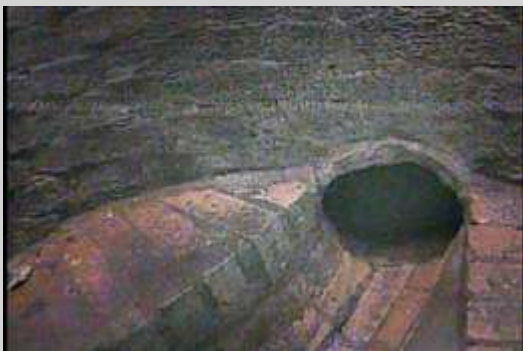
3 O'Clock Inflow

Pipe Height: **7.2** (in.) Rod and Bar (Angled)
Pipe Material: **Clay** ☐ Pipe Lined
Invert Depth: **9.45** (ft.) Flow Characteristics: **Slow**
Deposits: ☒ None ☐ Mud ☐ Sludge ☐ Debris ☐ Grease
Silt Depth: (in.) Deposits Extent:
Infiltration: **None** Pipe Seal Cond: **Broken**
